State of California
The Resources Agency
DEPARTMENT OF WATER RESOURCES
Division of Flood Management

**SEPTEMBER
2002
OFFICE REPORT**

**THE INSPECTION OF FLOOD CONTROL STRUCTURES
ON THE SACRAMENTO AND SAN JOAQUIN RIVERS
AND THEIR TRIBUTARIES**

**Prepared By The
Flood Operations Branch
FLOOD PROJECT INSPECTION SECTION**

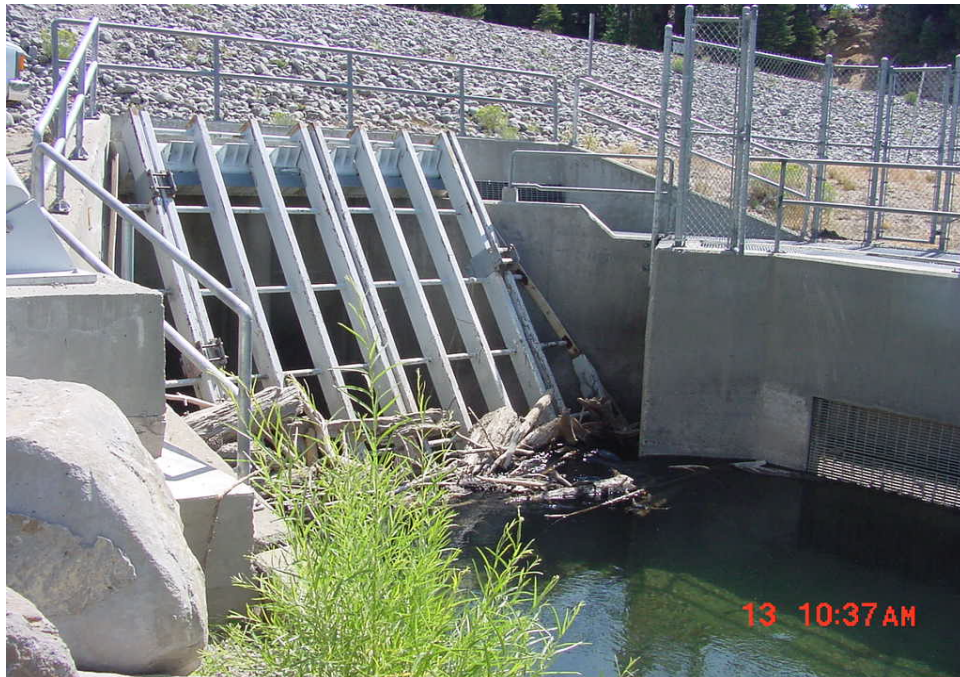
- 1. Condition of concrete diversion structure.**
 - a. Good.**
- 2. Condition of the gauging house and equipment.**
 - a. Fair. There are still numerous bullet holes in the door.**
- 3. Condition of the steel trash racks.**
 - a. Good.**
- 4. Condition of debris deflection structure.**
 - a. Good. The damaged sections reported in the 1998 Structure Report have been repaired.**
- 5. Condition of the revetments.**
 - a. Good.**
- 6. Accumulation of trash and debris around structure or in the channel.**
 - a. Minimal amount of debris around the deflection structure.**
- 7. Vegetation around the structure or in the channel.**
 - a. None.**
- 8. Condition of the conduits.**
 - a. The center conduit was inspected this year and found to be in good condition. However the separations at the joints between the monoliths have increased.**

The diversion structure at the conduit inlet.

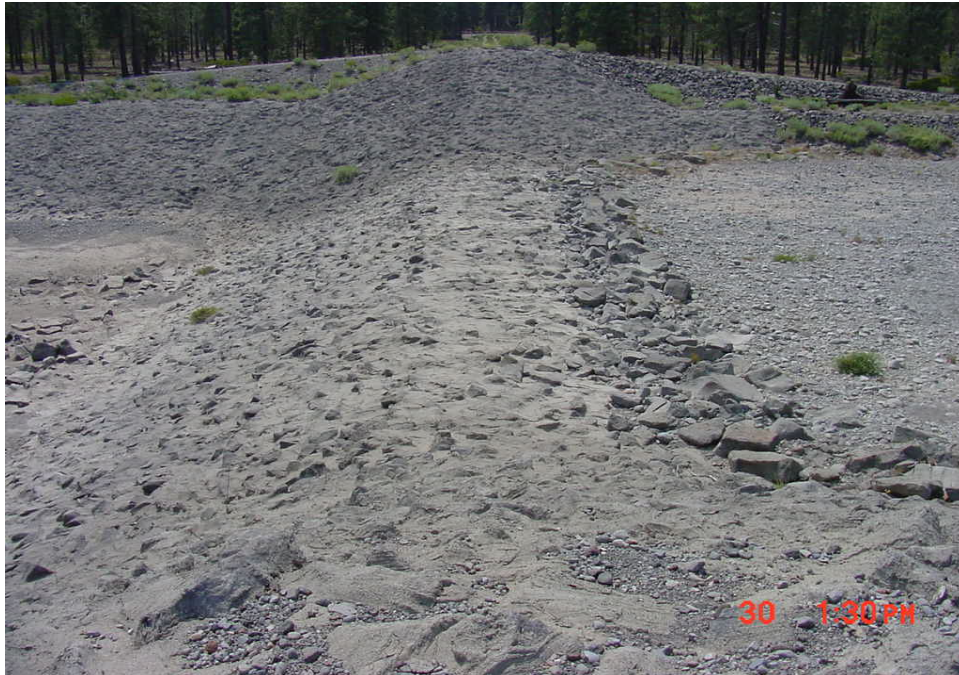
1. Condition of grouted rock revetment drop structure.
 - a. Good.
2. Condition of channel banks upstream and downstream of the drop structure.
 - a. Good.
3. Accumulation of trash and debris around the structure or in the channel.
 - a. None.
4. Vegetation around the structure, in the channel banks or in the channel.
 - a. None.
5. Comments:
 - a. Good maintenance.

The structure from the left bank.

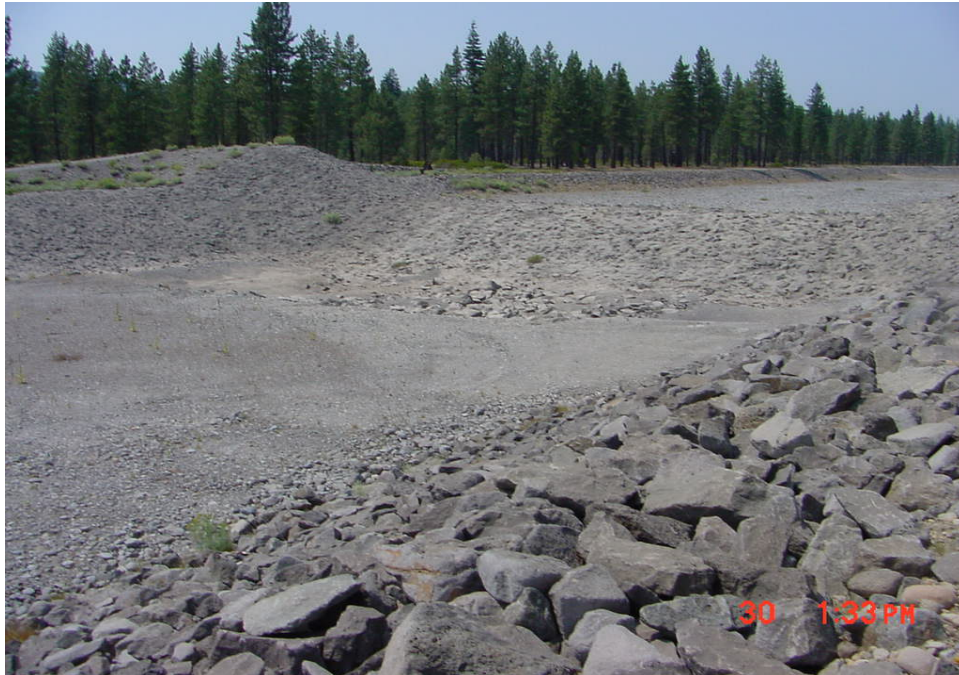
1. Condition of grouted rock revetment drop structure.
 - a. Good.
2. Condition of the channel banks upstream and downstream of the drop structure.
 - a. Good.
3. Accumulation of trash and debris around the structure or in the channel.
 - a. None.
4. Vegetation around the structure, in the channel banks or in the channel.
 - a. Minimal.
5. Comments:
 - a. Good maintenance.

Upstream at the drop structure from the left bank.

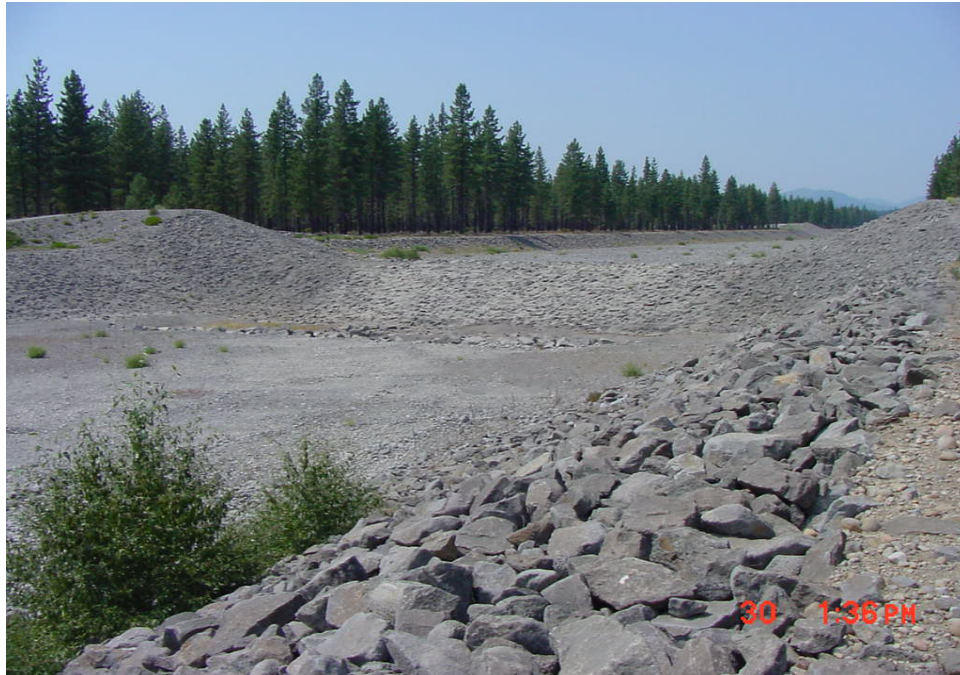
1. Condition of grouted rock revetment drop structure.
 - a. Good.
2. Condition of channel banks upstream and downstream of the drop structure.
 - a. Good.
3. Accumulation of trash and debris around the structure or in the channel.
 - a. None.
4. Vegetation around the structure, in the channel banks or in the channel.
 - a. None.
5. Comments:
 - a. Good maintenance.

Upstream at the drop structure from the left bank.

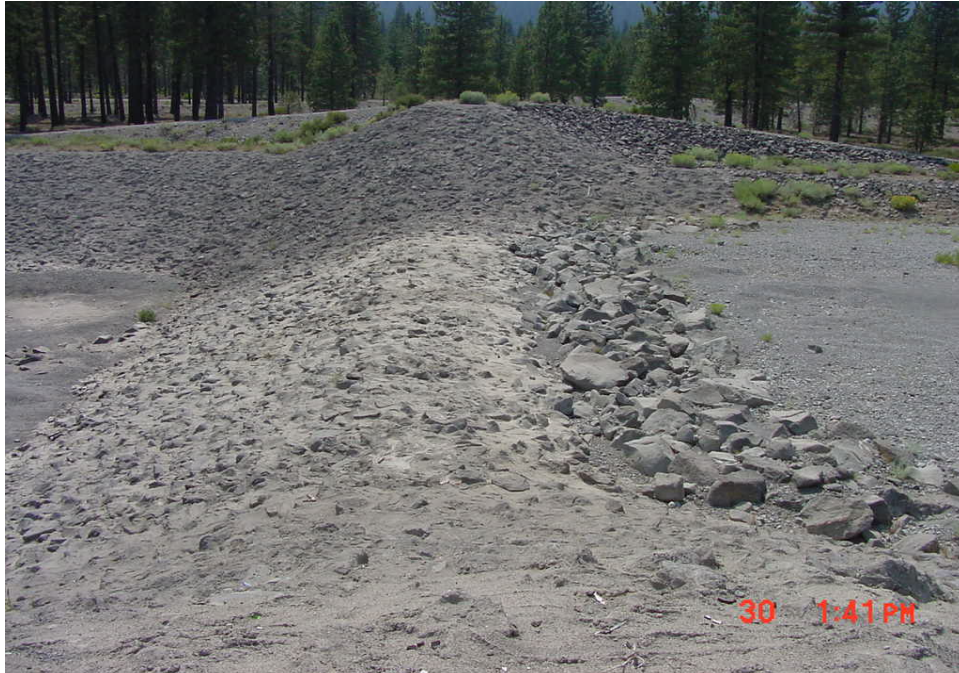
1. Condition of grouted rock revetment drop structure.
 - a. Good.
2. Condition of channel banks upstream and downstream of the drop structure.
 - a. Good.
3. Accumulation of trash and debris around the structure or in the channel.
 - a. None.
4. Vegetation around the structure, in the channel banks or in the channel.
 - a. None.
5. Comments:
 - a. Good maintenance.

The drop structure from the left bank.

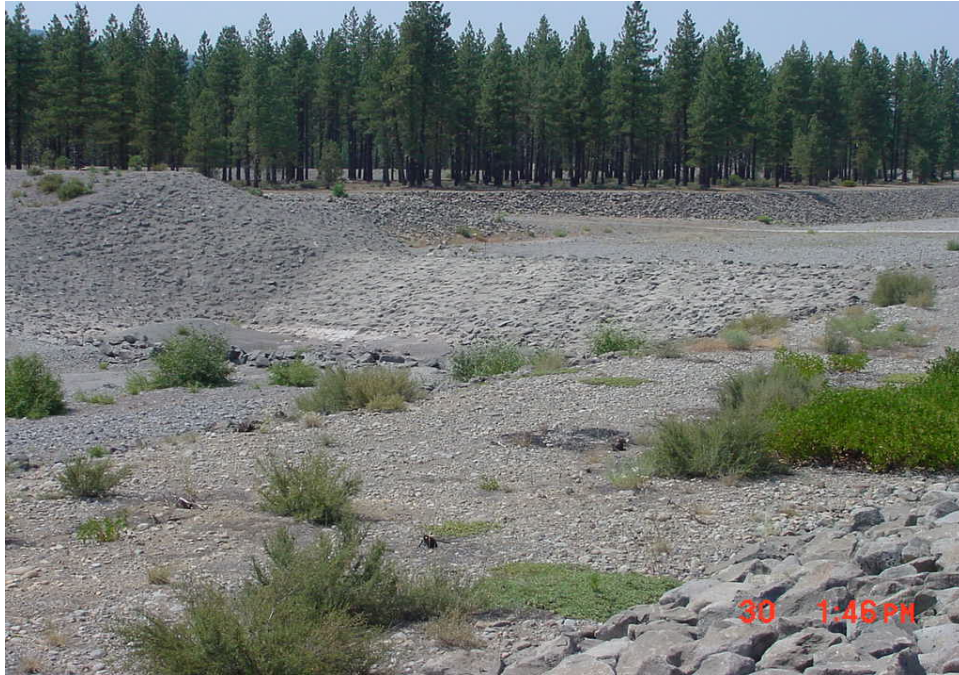
1. Condition of grouted rock revetment drop structure.
 - a. Good.
2. Condition of channel banks upstream and downstream of the drop structure.
 - a. Good.
3. Accumulation of trash and debris around the structure or in the channel.
 - a. None.
4. Vegetation around the structure, in the channel banks or in the channel.
 - a. None.
5. Comments:
 - a. Good maintenance.

Upstream at the drop structure from the left bank.

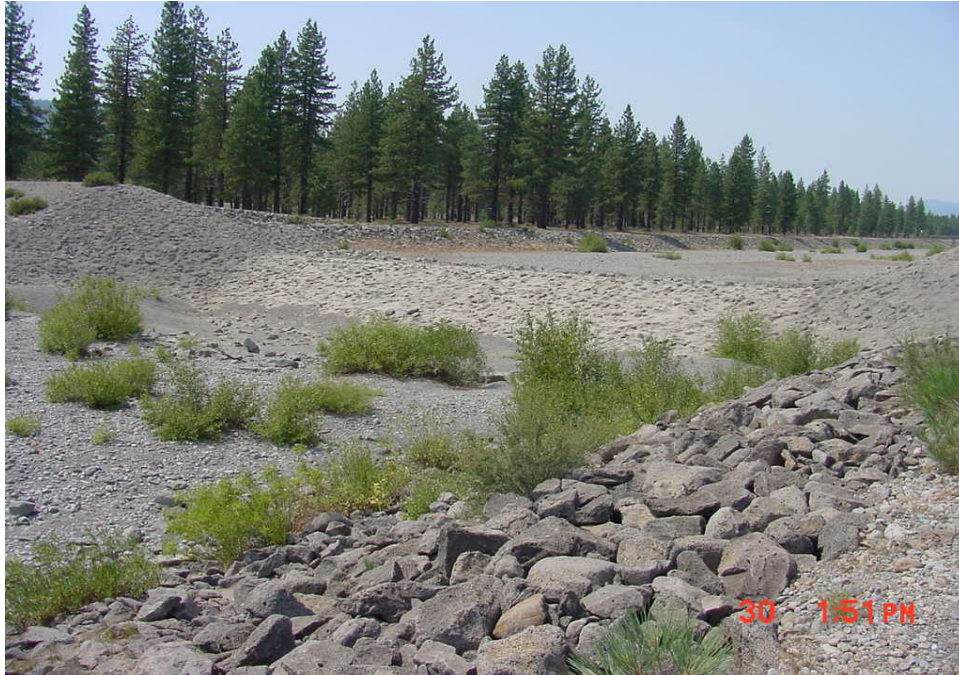
1. Condition of grouted rock revetment drop structure.
 - a. Good.
2. Condition of channel banks upstream and downstream of the drop structure.
 - a. Good.
3. Accumulation of trash and debris around the structure or in the channel.
 - a. None.
4. Vegetation around the structure, in the channel banks or in the channel.
 - a. Minimal.
5. Comments:
 - a. Good maintenance.

Upstream side of structure from the left bank.

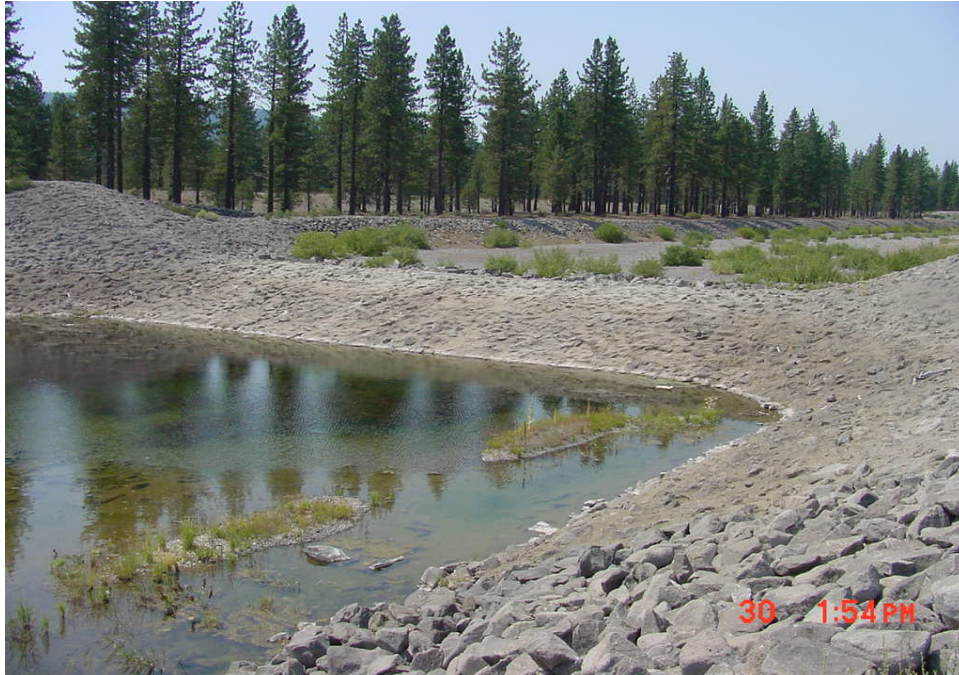
1. Condition of grouted rock revetment drop structure.
 - a. Good.
2. Condition of channel banks upstream and downstream of the drop structure.
 - a. Good.
3. Accumulation of trash and debris around the structure or in the channel.
 - a. None.
4. Vegetation around the structure, in the channel banks or in the channel.
 - a. Minimal.
5. Comments:
 - a. Good maintenance.

Upstream at the drop structure from the left bank.

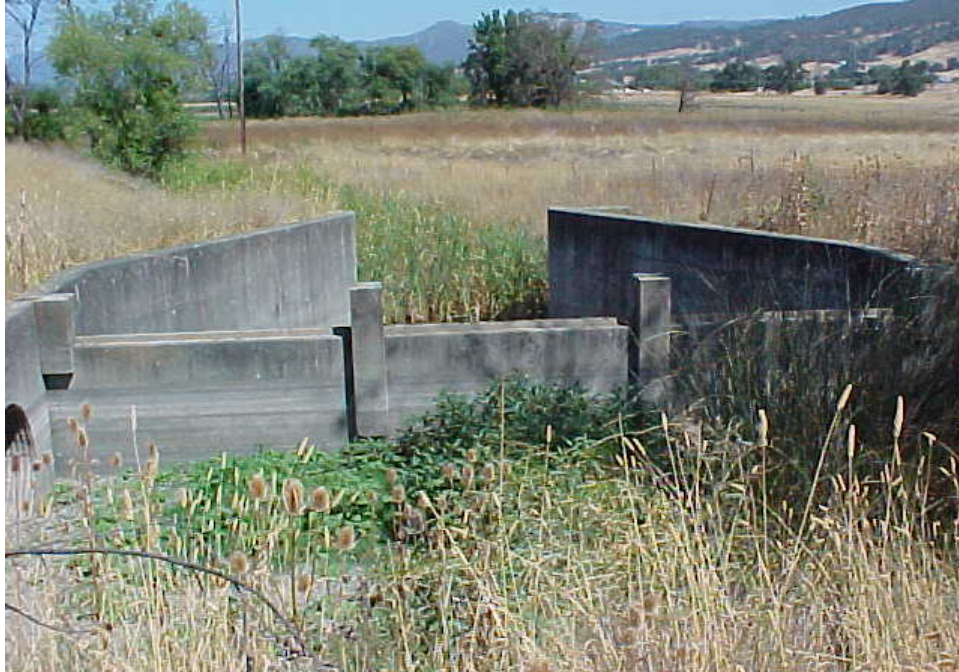
1. Condition of concrete weir structure and stilling basin.
 - a. Good.
2. Condition of drainage structure.
 - a. Good.
3. Condition of the concrete abutments and wing walls.
 - a. There is a displacement between both wing walls and the structure, 2 inches on left wing wall and two ½ inches on the right wing wall. Displacement has been stable for at least 5 years.
4. Condition of the revetment.
 - a. Good.
5. Accumulation of trash and debris around the structure or in the channel.
 - a. None.
6. Vegetation around the structure or in the channel.
 - a. Minimal tule growth in discharge channel.
7. Comments:
 - a. Good maintenance.

Downstream at the concrete weir from the left bank.

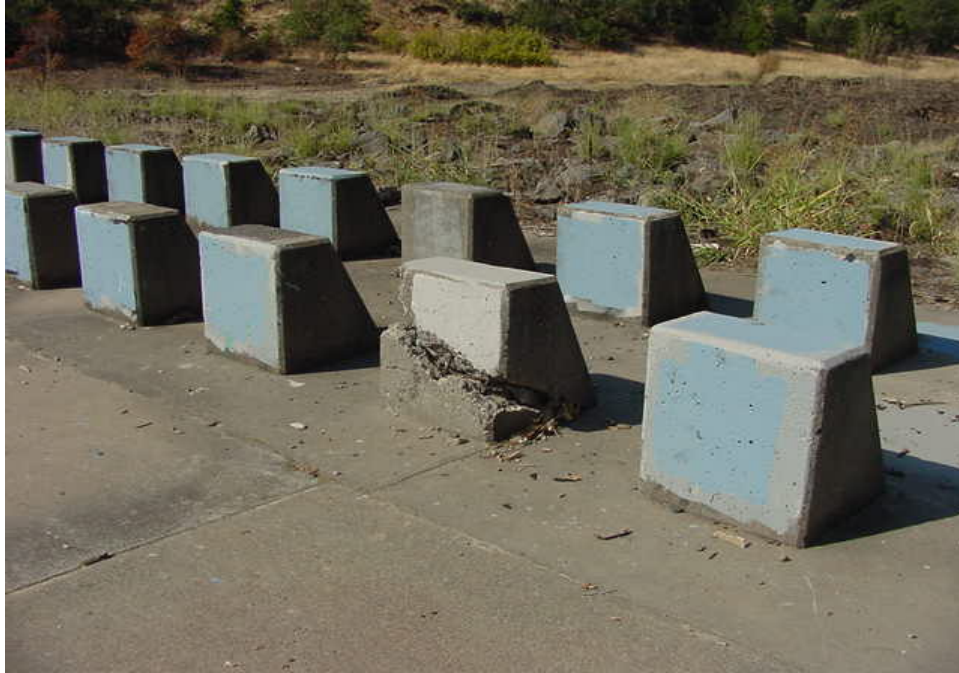
- 1. Condition of concrete weir structure and stilling basin, and velocity dissipaters.**
 - a. There are minor joint separations on the north and south ends of the weir where it contacts the abutments.**
 - b. There is minor damage to several velocity dissipaters and severe damage to one.**
- 2. Condition of concrete abutments and wing walls.**
 - a. Good.**
- 3. Condition of revetment.**
 - a. Good.**
- 4. Accumulation of trash and debris around the structure or in the channel.**
 - a. None.**
- 5. Vegetation around structure or in the channel.**
 - a. Minimal.**
- 6. Condition of gauging house and equipment.**
 - a. Fair.**
- 7. Comments:**
 - a. Repair the severely damaged velocity dissipater. This was first noted in the 2000 Structure Report but has not been repaired.**
 - b. Remove vegetation from channel.**
 - c. Fair maintenance.**

View of severely damaged velocity dissipater.

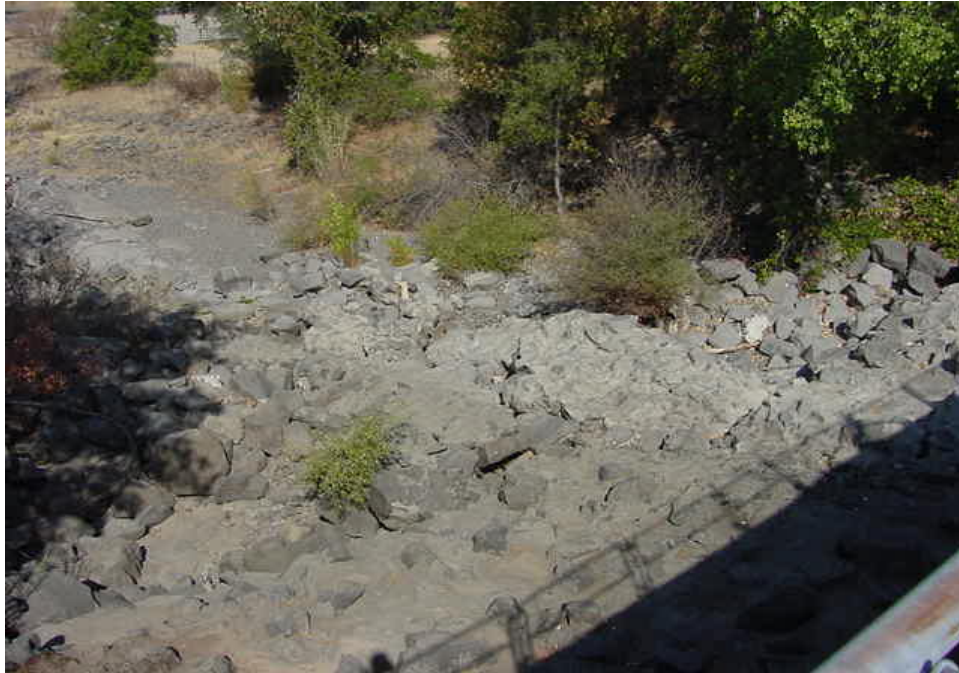
1. Conditions of concrete control structure.
 - a. Good.
2. Condition of bulkheads.
 - a. There is a ½ inch separation in the joint between the south end bulkhead and the structure. This joint separation is stable.
3. Condition of control gates and mechanisms.
 - a. Good.
4. Condition of revetment.
 - a. Poor. The downstream rock and gunite skirt is severely damaged.
5. Accumulation of trash and debris around the structure or in the channel.
 - a. None.
6. Vegetation around the control structure or in the channel.
 - a. None.
7. Comments:
 - a. Butte Co. will test the control gates prior to flood season.
 - b. Repair the rock and gunite skirt downstream of structure.
 - c. Fair maintenance.

View of damaged rock and gunite skirt down stream of structure.

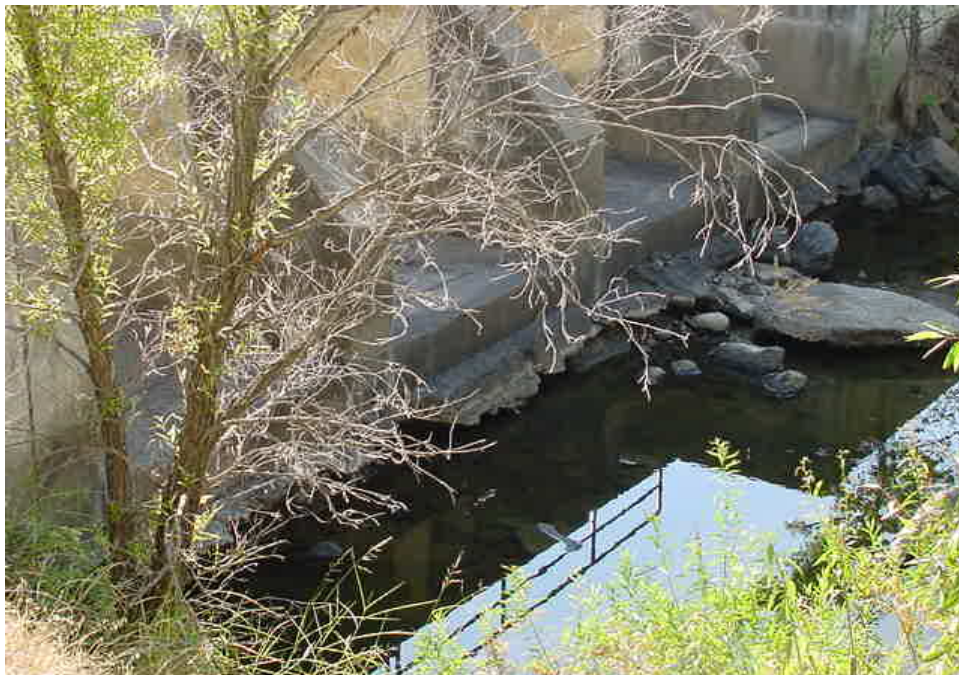
1. Condition of concrete control structure.
 - a. Fair. The base at the downstream side of the control structure is beginning to undermine.
2. Condition of bulkheads and wing walls of the control structure.

- a. Poor. The revetment/gunite apron on the downstream end of the control structure is severely damaged.
7. Condition of the log boom.
 - a. The log boom was removed by Sutter Maintenance Yard several years ago and there are no plans to reinstall it.

**Downstream side of the control structure.
The gunite apron is severely damaged and the structure is partially undermined.**

9. Accumulation of trash and debris around the structures or in the channel.
 - a. Minimal.
10. Vegetation around the control structure, the weir, or in the channel.
 - a. Sutter Maintenance Yard was removing vegetation at the time of the inspection.
11. Comments:
 - a. Repair the control structure base (downstream side) as soon as possible.
 - b. Continue to monitor joint separation between the control structure and the abutments and repair as needed.
 - c. Remove driftwood and cobbles from dissipaters.
 - d. Fair maintenance.

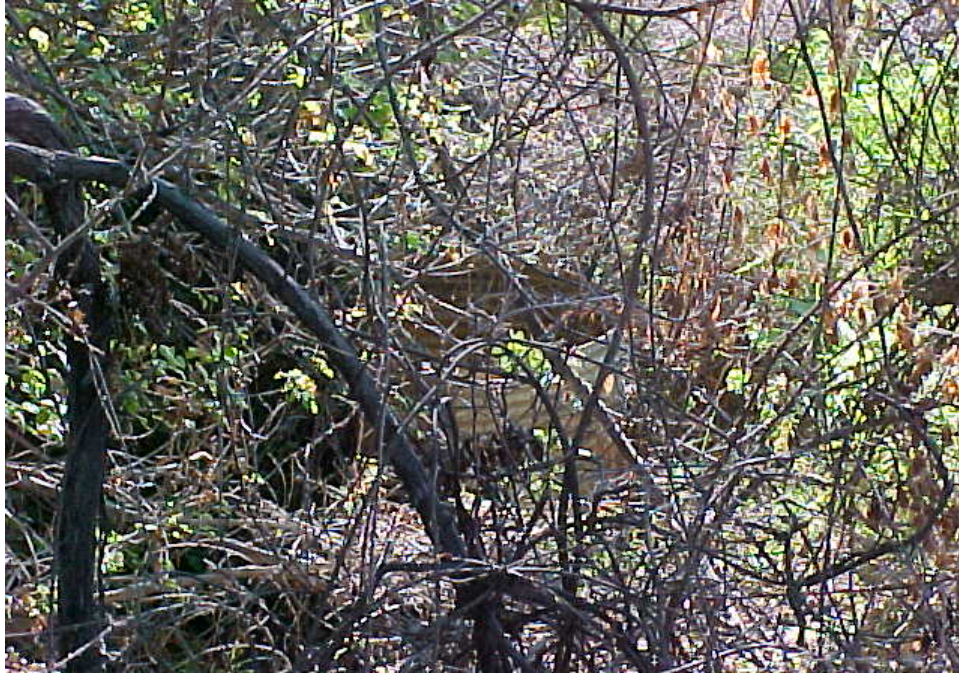
1. Condition of the corrugated metal pipe (CMP) drainage structure.
 - a. Good.
2. Condition of the control gate, mechanisms, and flap gates.
 - a. Could not properly inspect due to excessive vegetation.
3. Condition of the revetment.
 - a. Good.
4. Accumulation of trash and debris around the inlet, in the pipe or in the channel.
 - a. Could not properly inspect due to excessive vegetation.
5. Vegetation around the structure or in the channel.
 - a. Heavy vegetation around structure. Growth is so dense that intake and discharge ends of structure cannot be seen.
6. Comments:
 - a. Remove vegetation from inlet and discharge ends of structure. If growth is not removed, the drainage structure could become non functional.
 - b. No maintenance.

**CMP stand pipe in the center
of picture, obscured by heavy growth.**

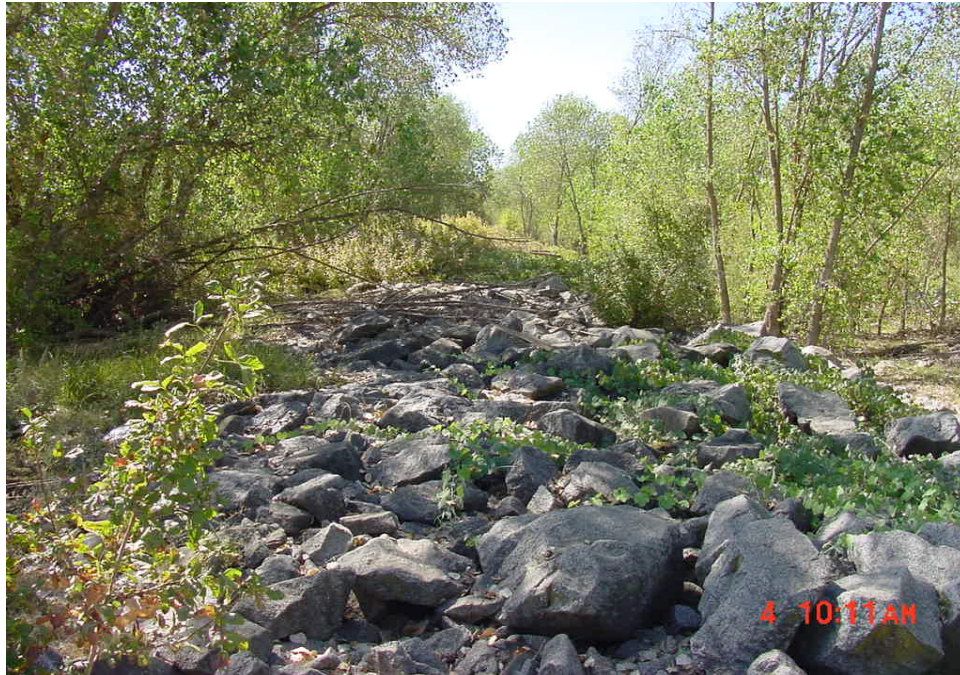
Looking southwest at the growth and debris on the rock weir.

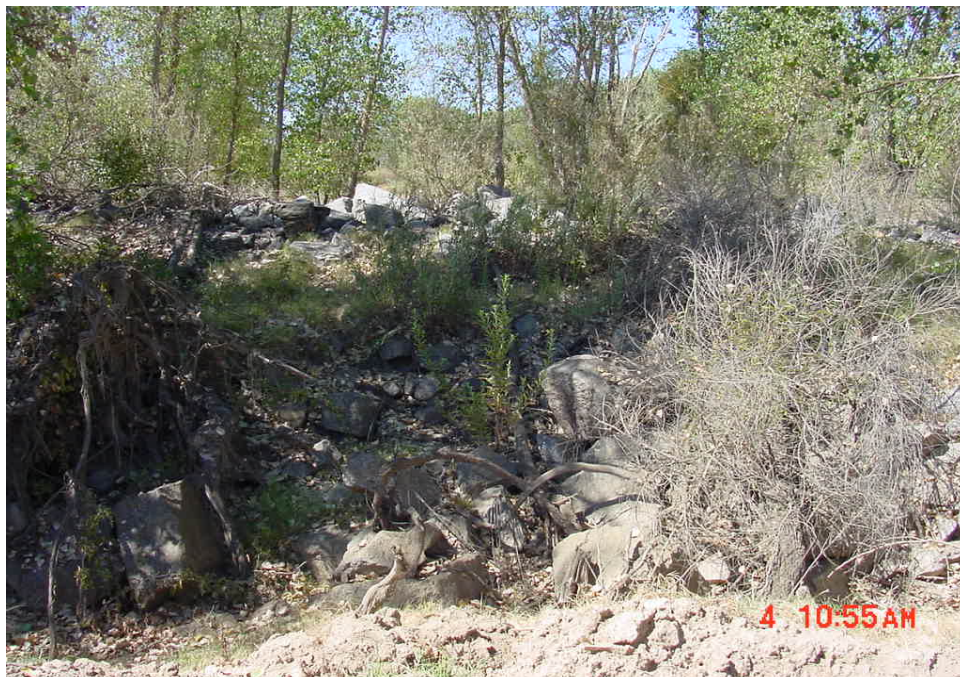
**Looking north from the approximate midway
point of the weir at the dense vegetation and debris.**

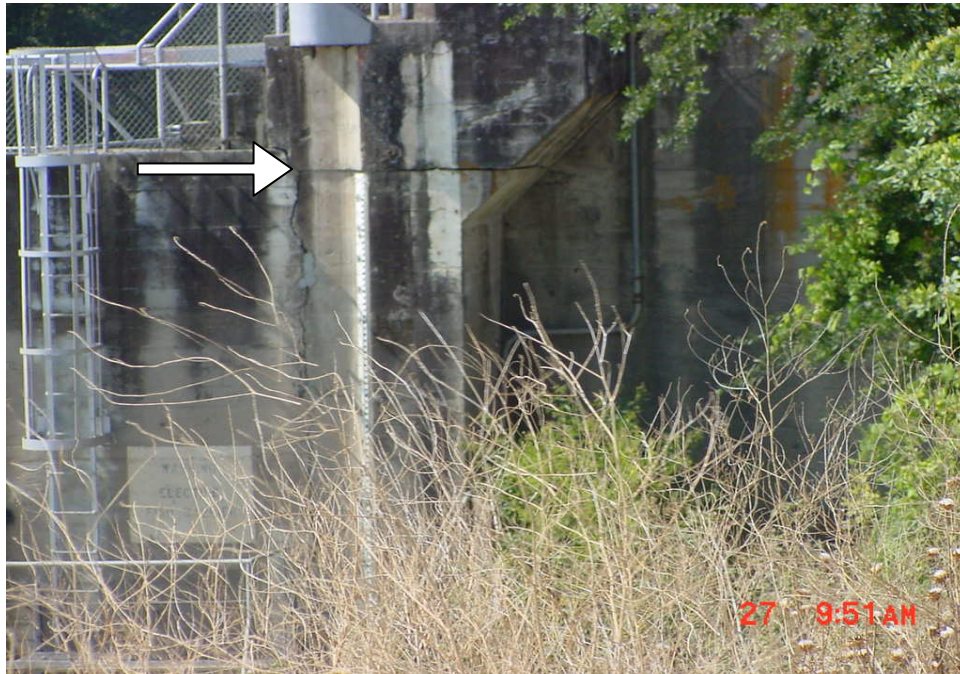
There is a large vertical crack and displacement on the downstream side of structure.

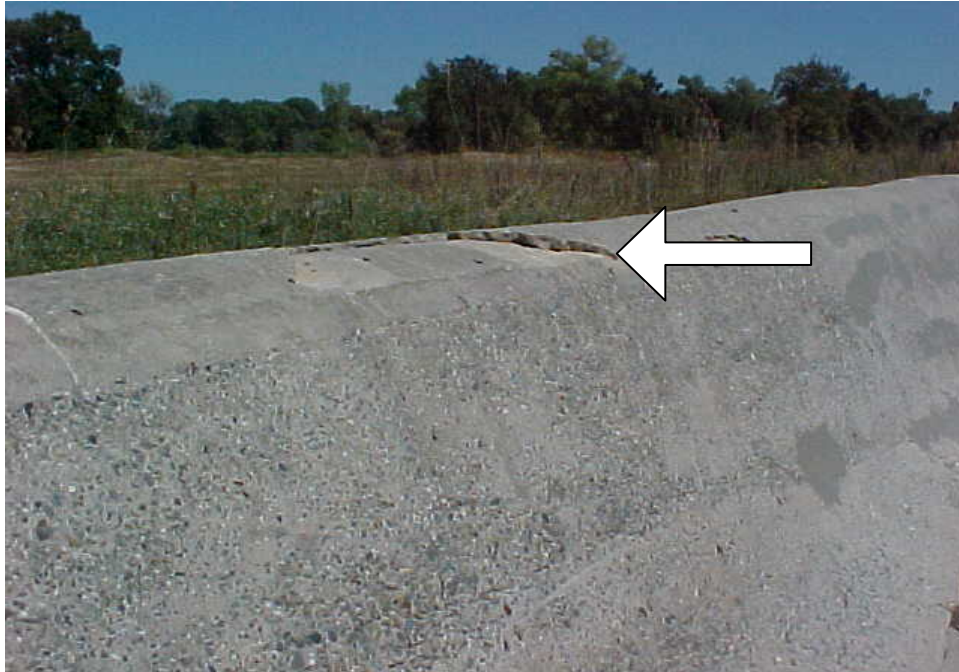
Spalling on the crown of the weir.

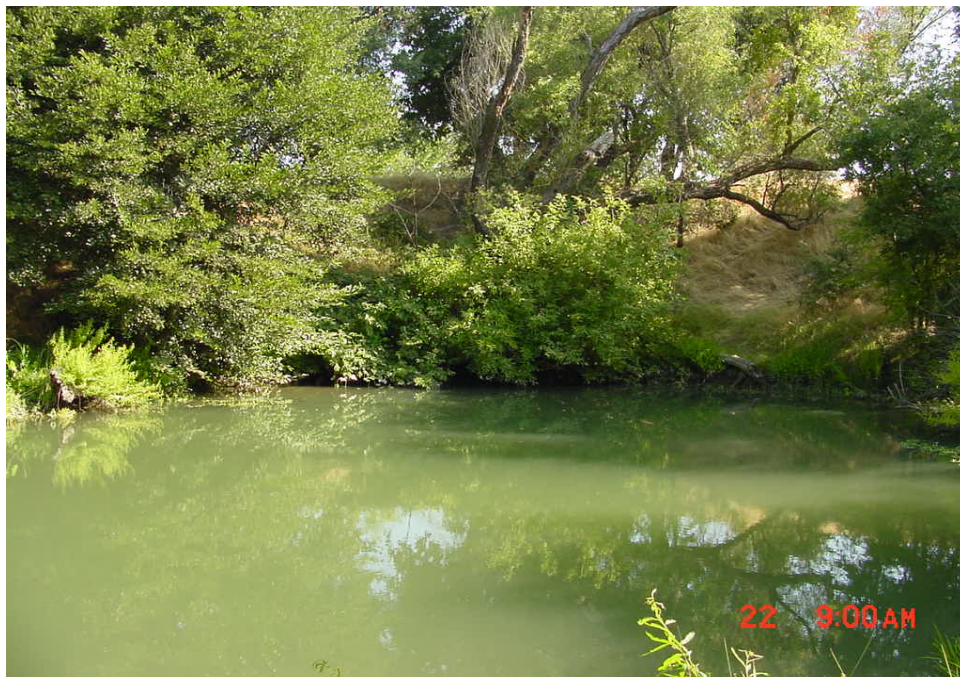
View of the discharge side into Elk Slough.
The structure is under water.

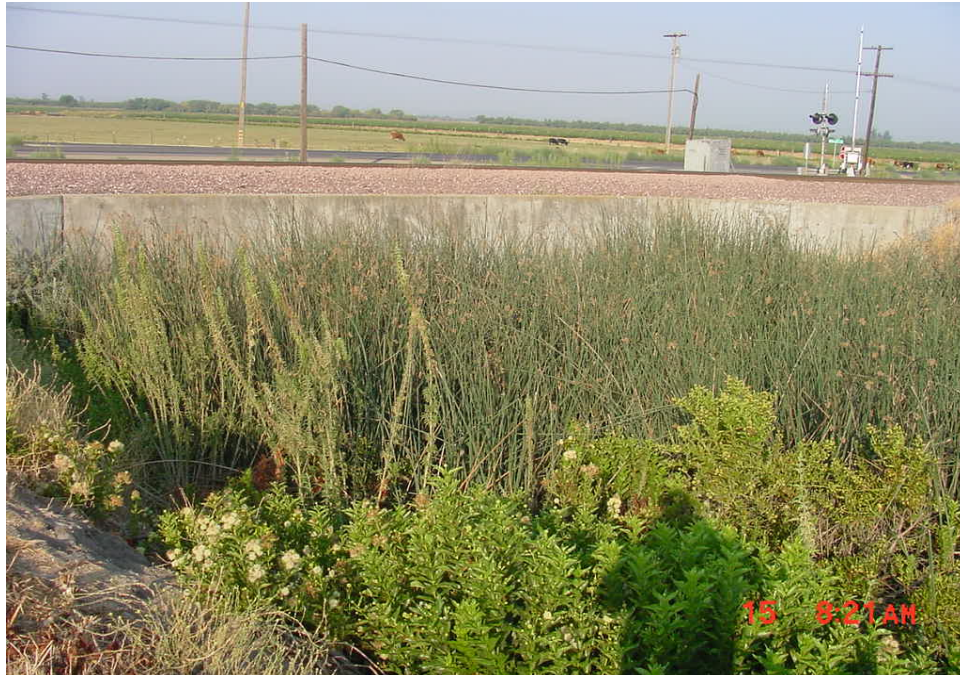
Upstream side of the structure and the heavy tule growth.

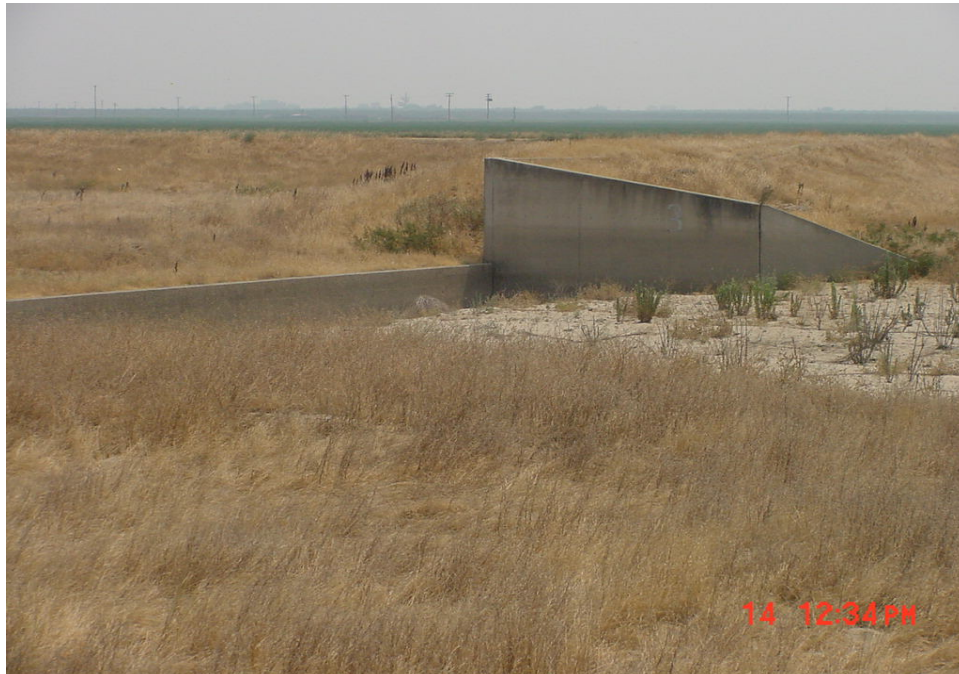
**Stilling basin and the
sand covered velocity dissipaters.**
